OUTER SKIN PROTECTION OF COLUMBIUM THERMAL PROTECTION SYSTEM (TPS) PANELS

by
John D. Culp

MCDONNELL DOUGLAS ASTRONAUTICS COMPANY

Contract NAS3-15546

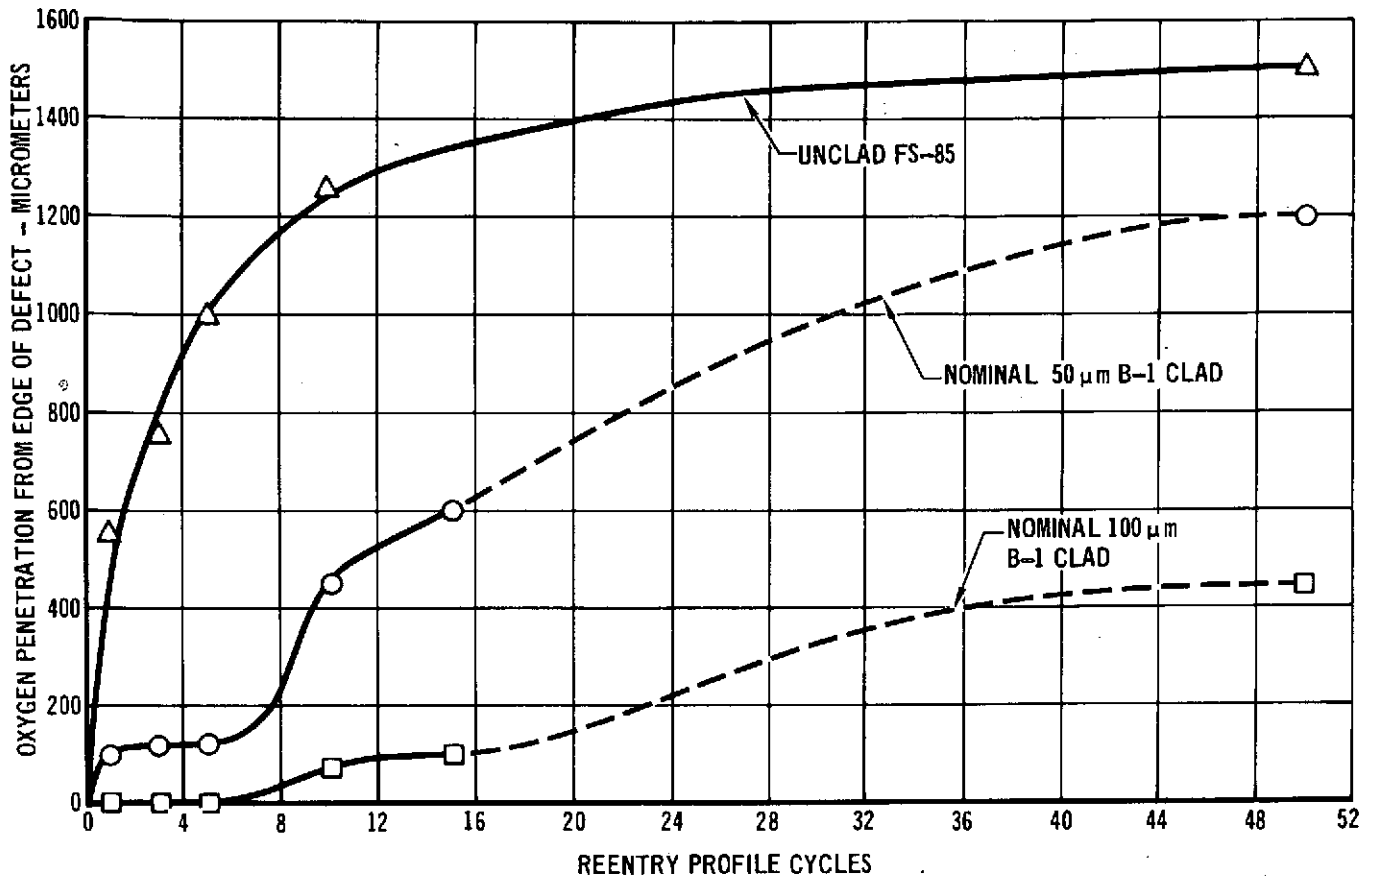
FIGURE ii

B-1 CLADDING LIMITS OXYGEN CONTAMINATION OF FS-85 CORE

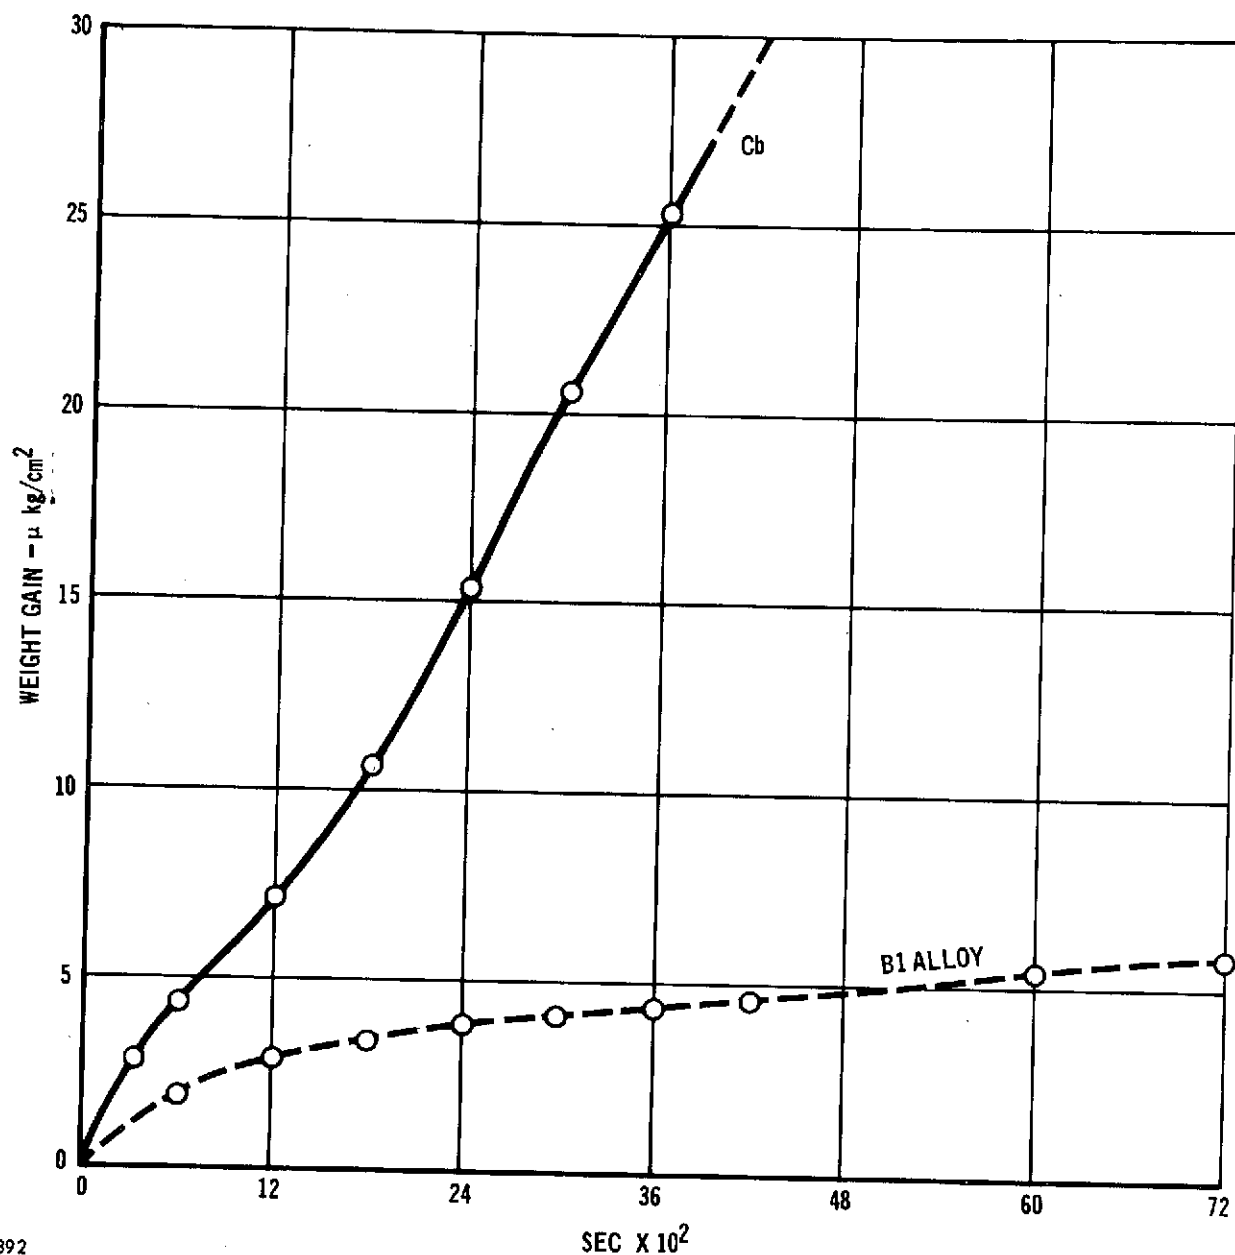
FIGURE 1 COMPARISON OF CONTINUOUS WEIGHT GAIN DATA FOR B1 ALLOY
AND PURE COLUMBIUM IN AIR AT 1040°C

The modified B-1 alloy was thought to be better in terms of oxidation resistance. (Figures 1 and 2 show oxidation test data for the B-1 available at the time of material selection.) The modified WC-3015 was considered to provide the program with information regarding strength of the composite system. While the minimum strength criterion was to maintain the core strength for 100 reuse cycles, it was believed that the WC-3015 might make a positive contribution to the composite strength. Prior to initiating manufacture of the WC-3015 cladding sheet, additional oxidation resistance data for the WC-3015 was published (reference 6). Reassessment of the oxidation resistance of the

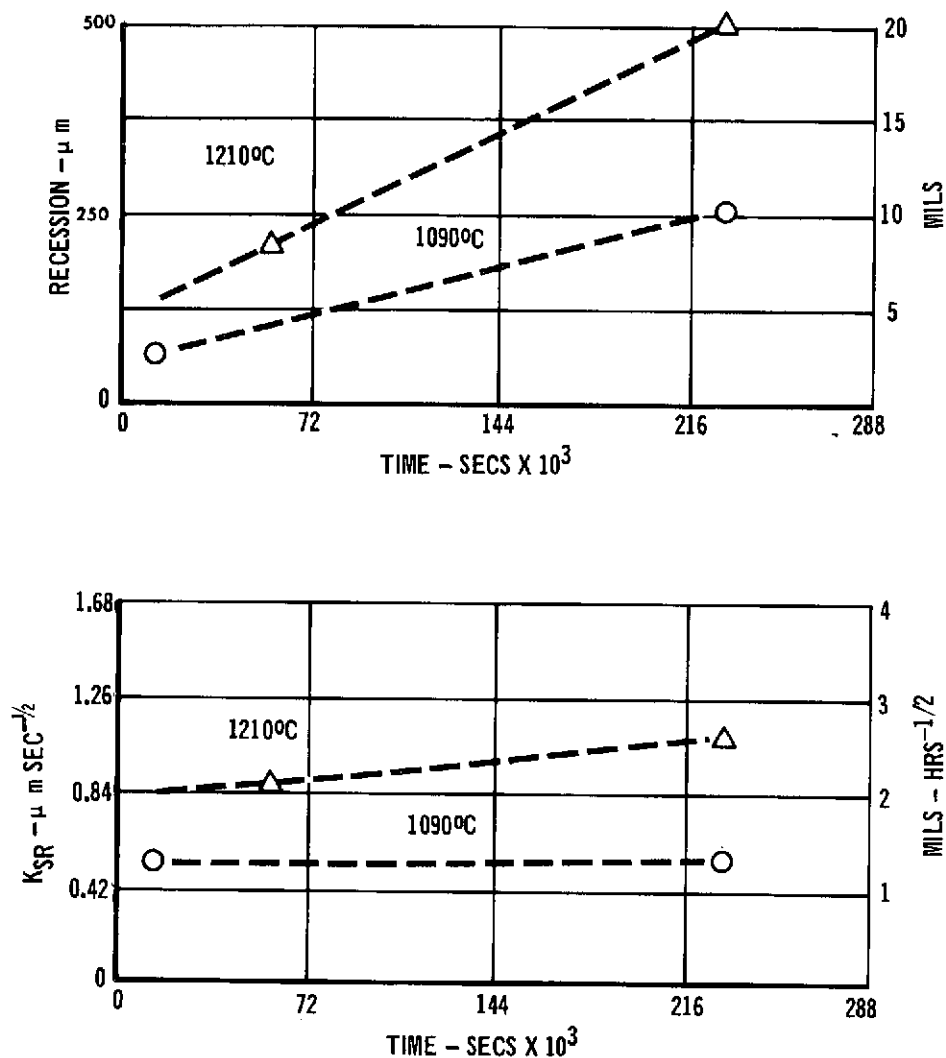
FIGURE 2 SURFACE RECESSON BEHAVIOR OF B-1 ALLOY OXIDIZED IN FLOWING AIR (DATA REPRESENTS 1/2 OF THE DIFFERENCE IN THICKNESS BEFORE AND AFTER EXPOSURE)

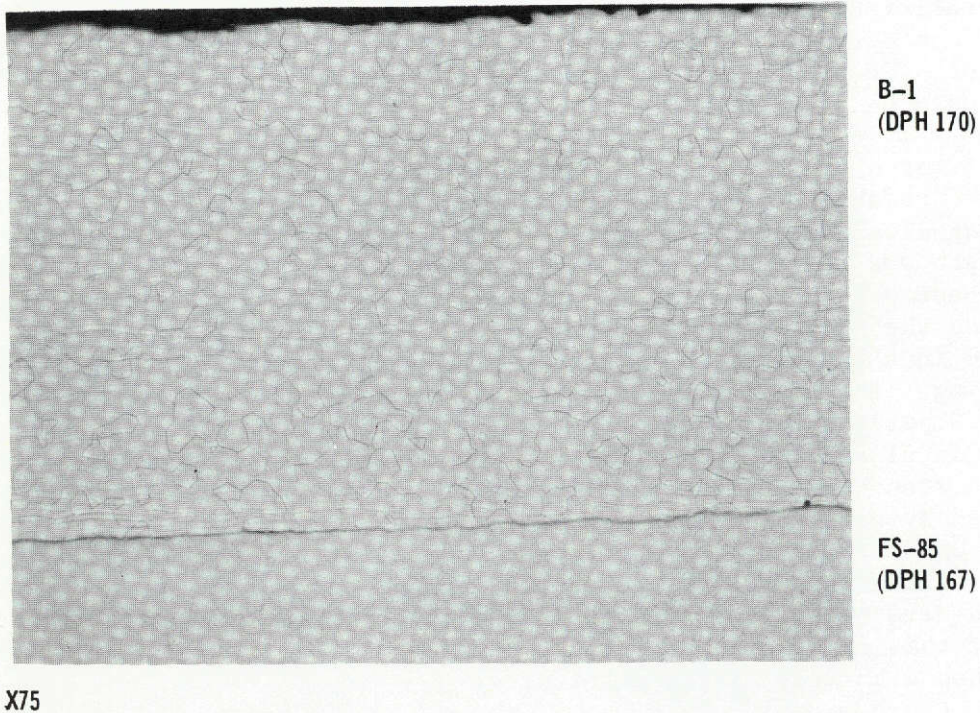
FIGURE 4 MICROSTRUCTURE OF ROLL BONDED B-1/FS-85 AFTER ANNEALING AT 1315°C

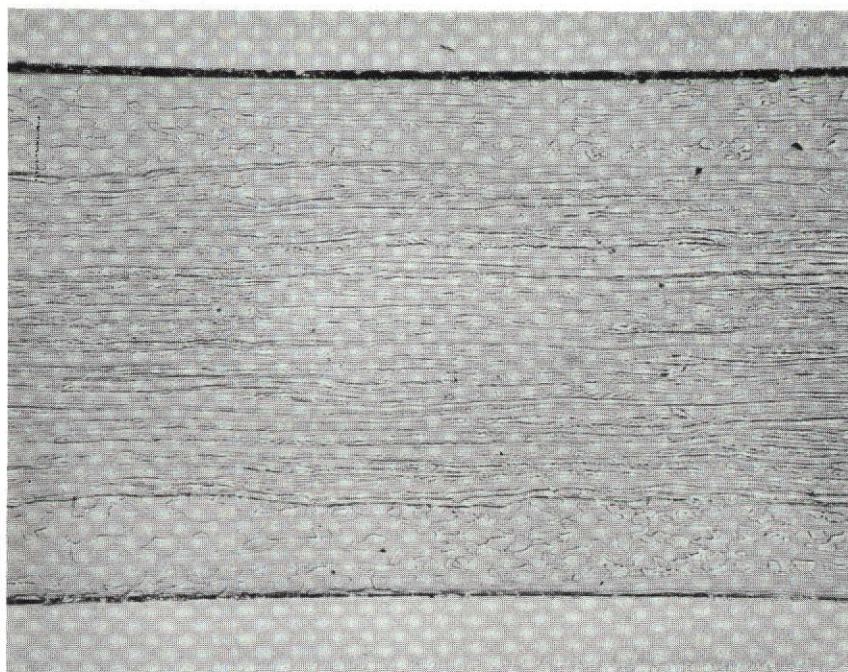
—— NICKEL BACKUP

—— B-1 CLADDING

FIGURE 7 MICROSTRUCTURE OF B-1 CLAD FS-85

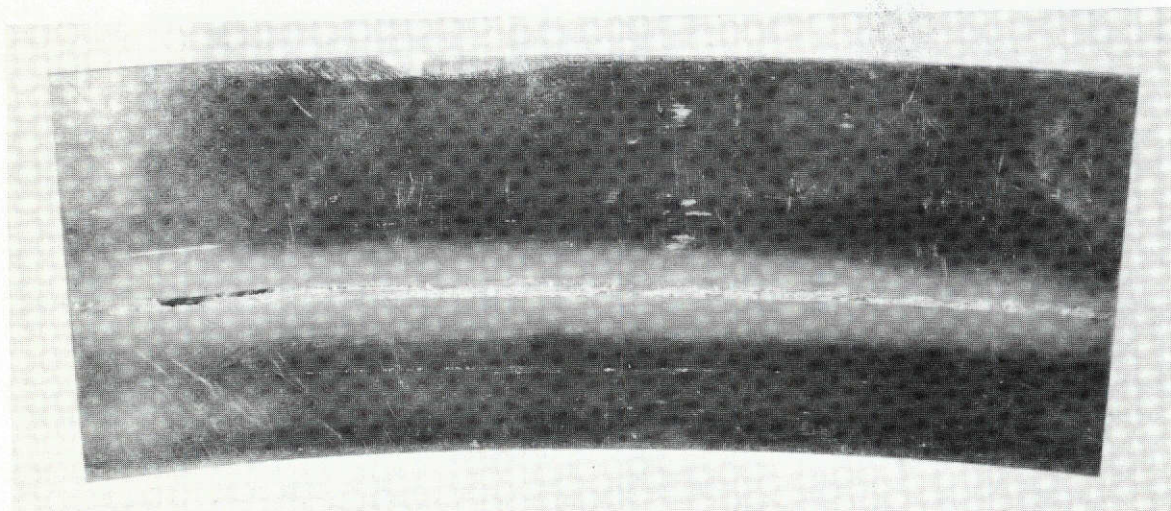
FIGURE 9 B-1 CLAD FS-85 PRODUCED DURING FINAL TASK SHOWING SURFACE
DELAMINATIONS

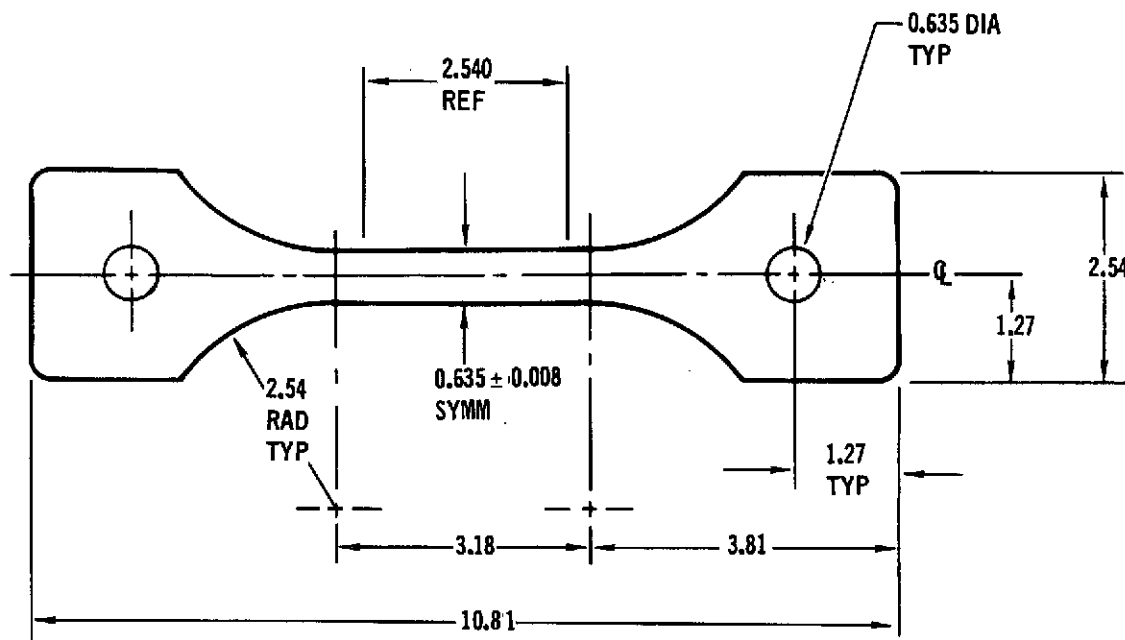
NOTE: ALL MEASUREMENTS ARE EXPRESSED IN CENTIMETERS

The B-1 clad FS-85 was fabricated into specimens for coating and evaluation. Bend coupons 2.5 by 5 centimeters, emittance specimens 2.5 by 2.5 centimeters and tensile coupons 2.5 by 10 centimeters as shown in figure 10 were fabricated using standard columbium alloy techniques. Shearing, drilling, machining (in the case of the tensile coupons) and edge preparation were accomplished without special handling and without difficulty. In no case did the B-1 cladding give an indication of becoming unbonded. It was found that steel stamping could be accomplished without detrimental effects to the cladding or the bond between the cladding and the core. The manufacturing procedures were acceptable and the results achieved were the same for the B-1 clad FS-85 and the Cb-752 and FS-85 baseline materials. Prior to coating, the thickness of each specimen and the gauge width of the tensile specimens were micrometer measured for coating thickness determination and for strength calculations.

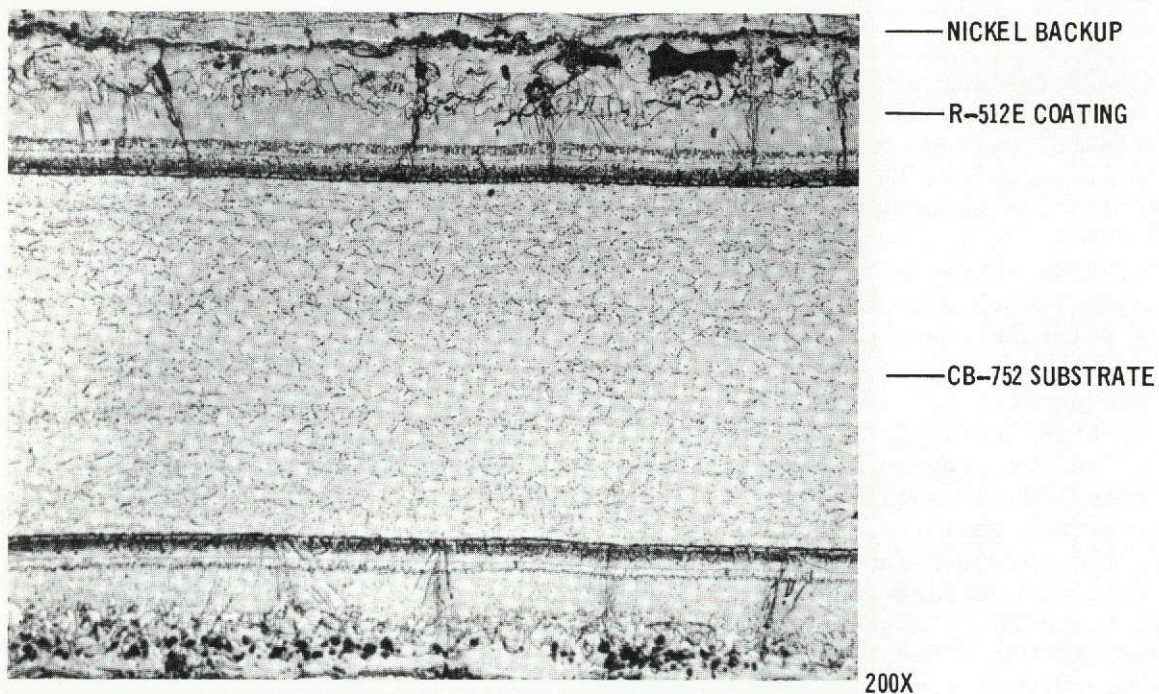
FIGURE 11 R-512E COATING ON CB-752

The R-512E coating on the Cb-752 baseline alloy had a normal coating structure, as shown in figure 11. The R-512E coating on the B-1 cladding alloy was slightly thicker and had a typical fused slurry silicide coating structure. Figure 12 shows the R-512E coating on the edge where a coating structure transition can be noted between the coating on the B-1 clad surface and the FS-85 alloy edge. The 30Cr-20Fe-Si composition on the B-1 clad material was the thickest. Most of the additional thickness was attributed to surface roughness, which has been previously noted with higher chromium content fused slurry silicide coatings (reference 7).

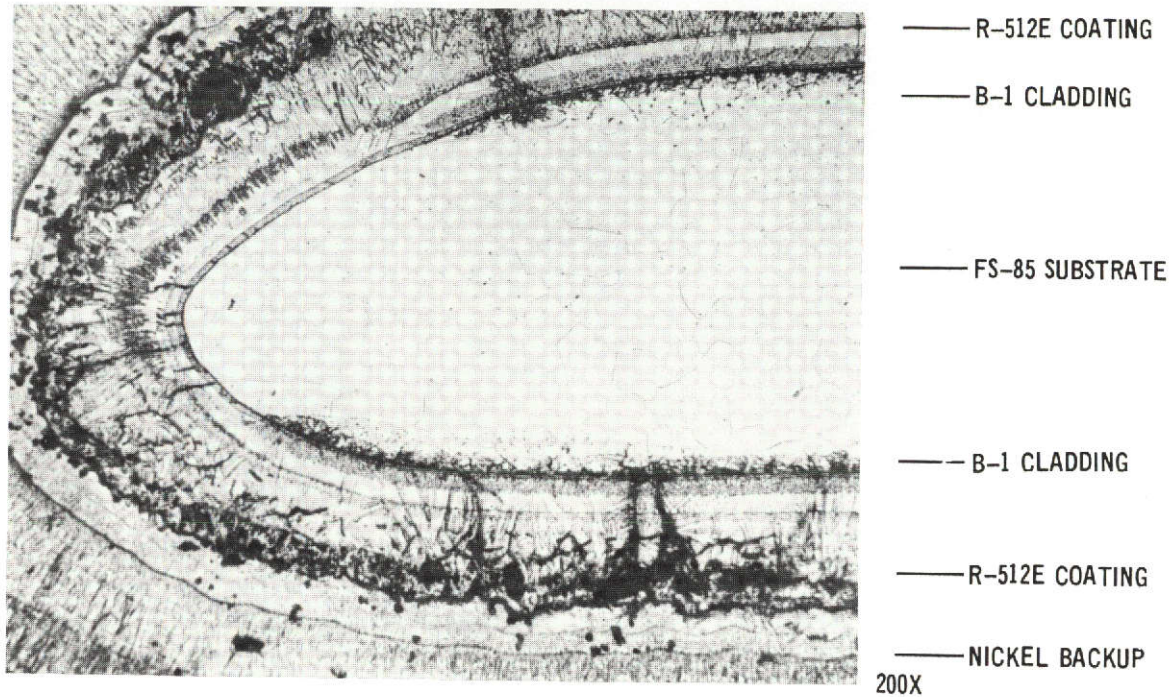
FIGURE 12 MICROSTRUCTURE OF R-512E COATING ON FS-85 (EDGE) AND B-1 (SURFACE)

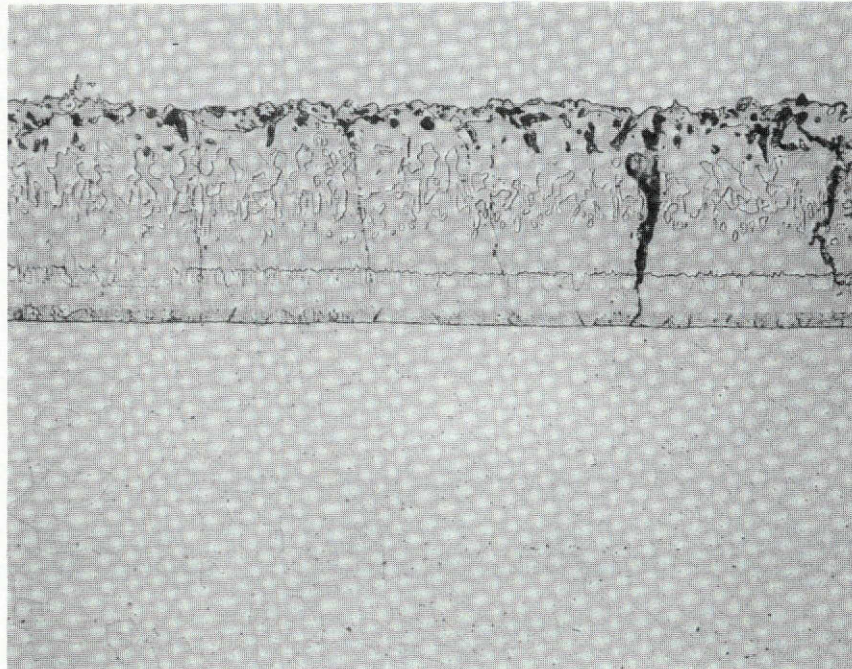
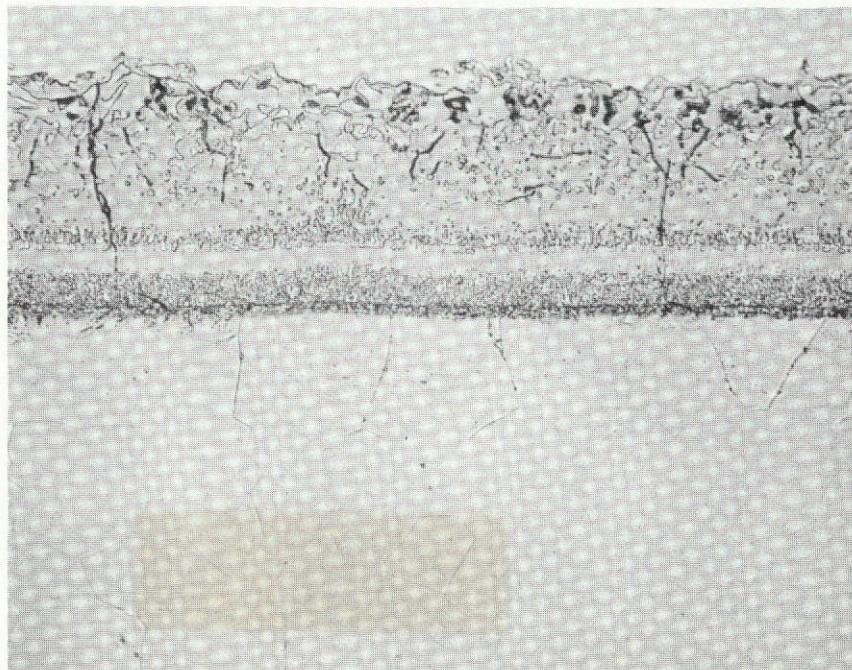
-NICKEL BACKUP
-R-512E COATING
-FS-85 SUBSTRATE

-NICKEL BACKUP
-R-512E COATING
-B-1 CLADDING
-FS-85-CORE

FIGURE 13 MICROSTRUCTURE OF R-512E COATING AS APPLIED IN TASK NO. 2

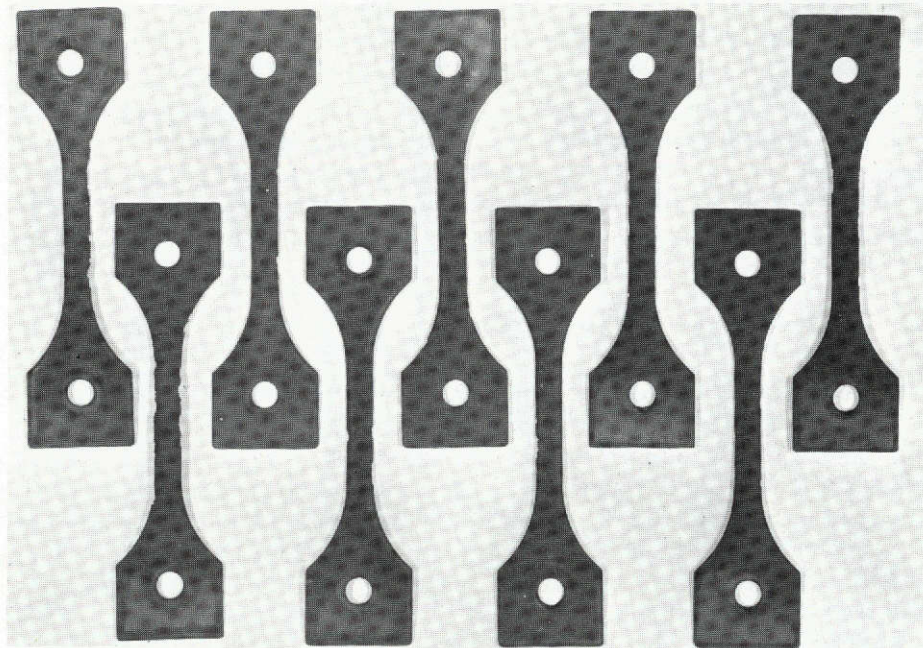
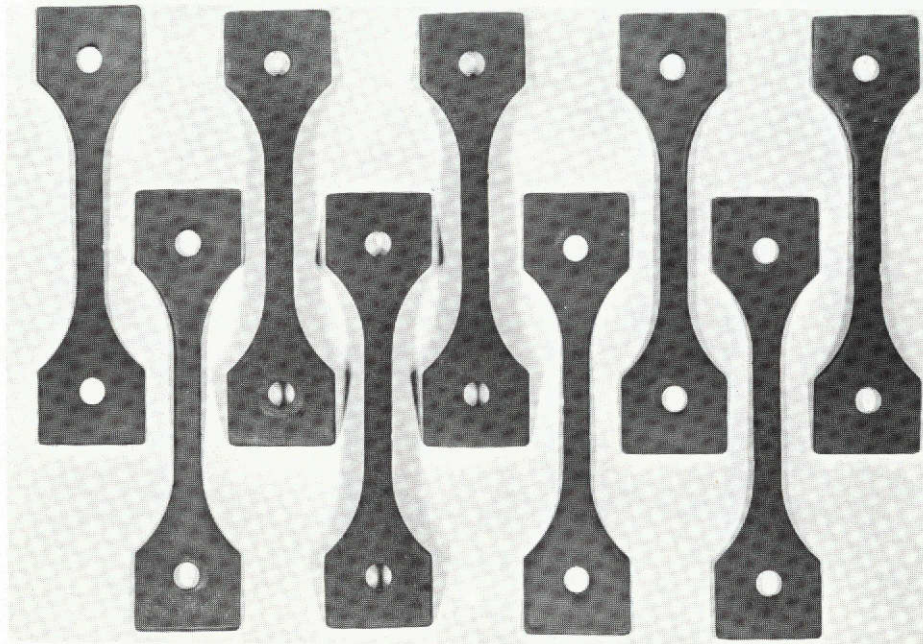
FIGURE 14 R512E COATED TENSILE SPECIMENS SHOWING OXIDATION SITES AFTER 100 REENTRY PROFILE EXPOSURE CYCLES

anomaly occurred with the clad tensile specimens during the 100 cycle exposure when numerous oxidation failures (shown in figure 14) occurred between the 88th and 100th cycle. Examination of metallographic sections made from both clad systems adjacent to an oxidation failure site did not reveal an obvious weakness in the protective system or the reason for the unusual premature failures. Figure 15 shows the edge microstructure observed for each of the clad systems. While incipient coating failures were observed in both specimens, the edges did not appear to be excessively sharp and the coating was of adequate thickness.

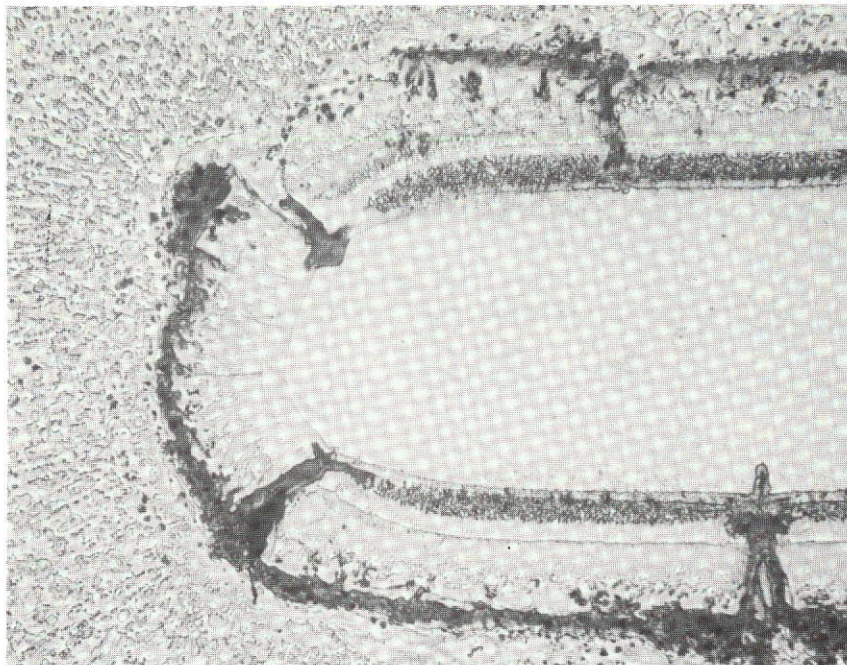
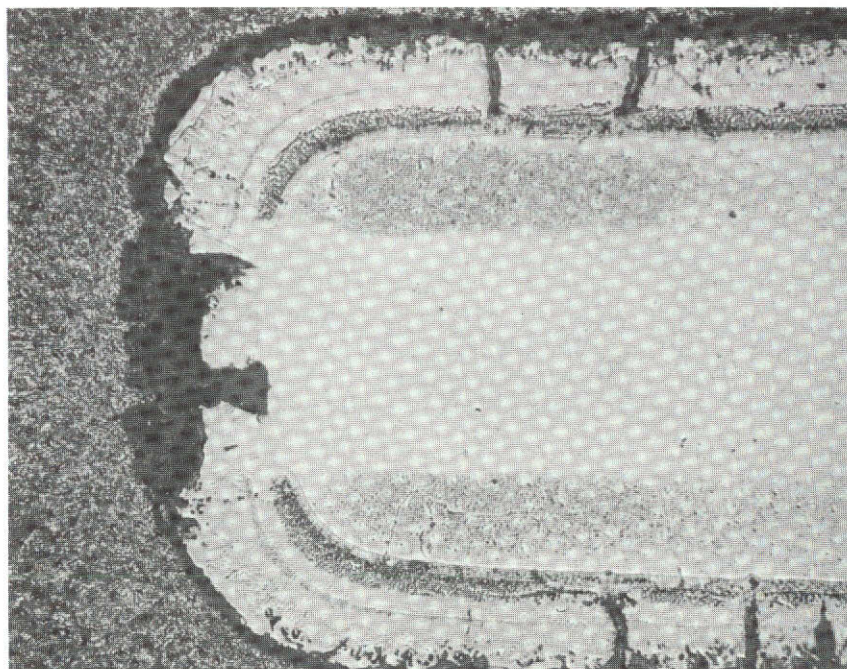
FIGURE 15 EDGE MICROSTRUCTURE OF R-512E COATED CLAD TENSILE SPECIMENS
ADJACENT TO COATING FAILURES OCCURRING WITHIN 100 REENTRY
PROFILE CYCLES

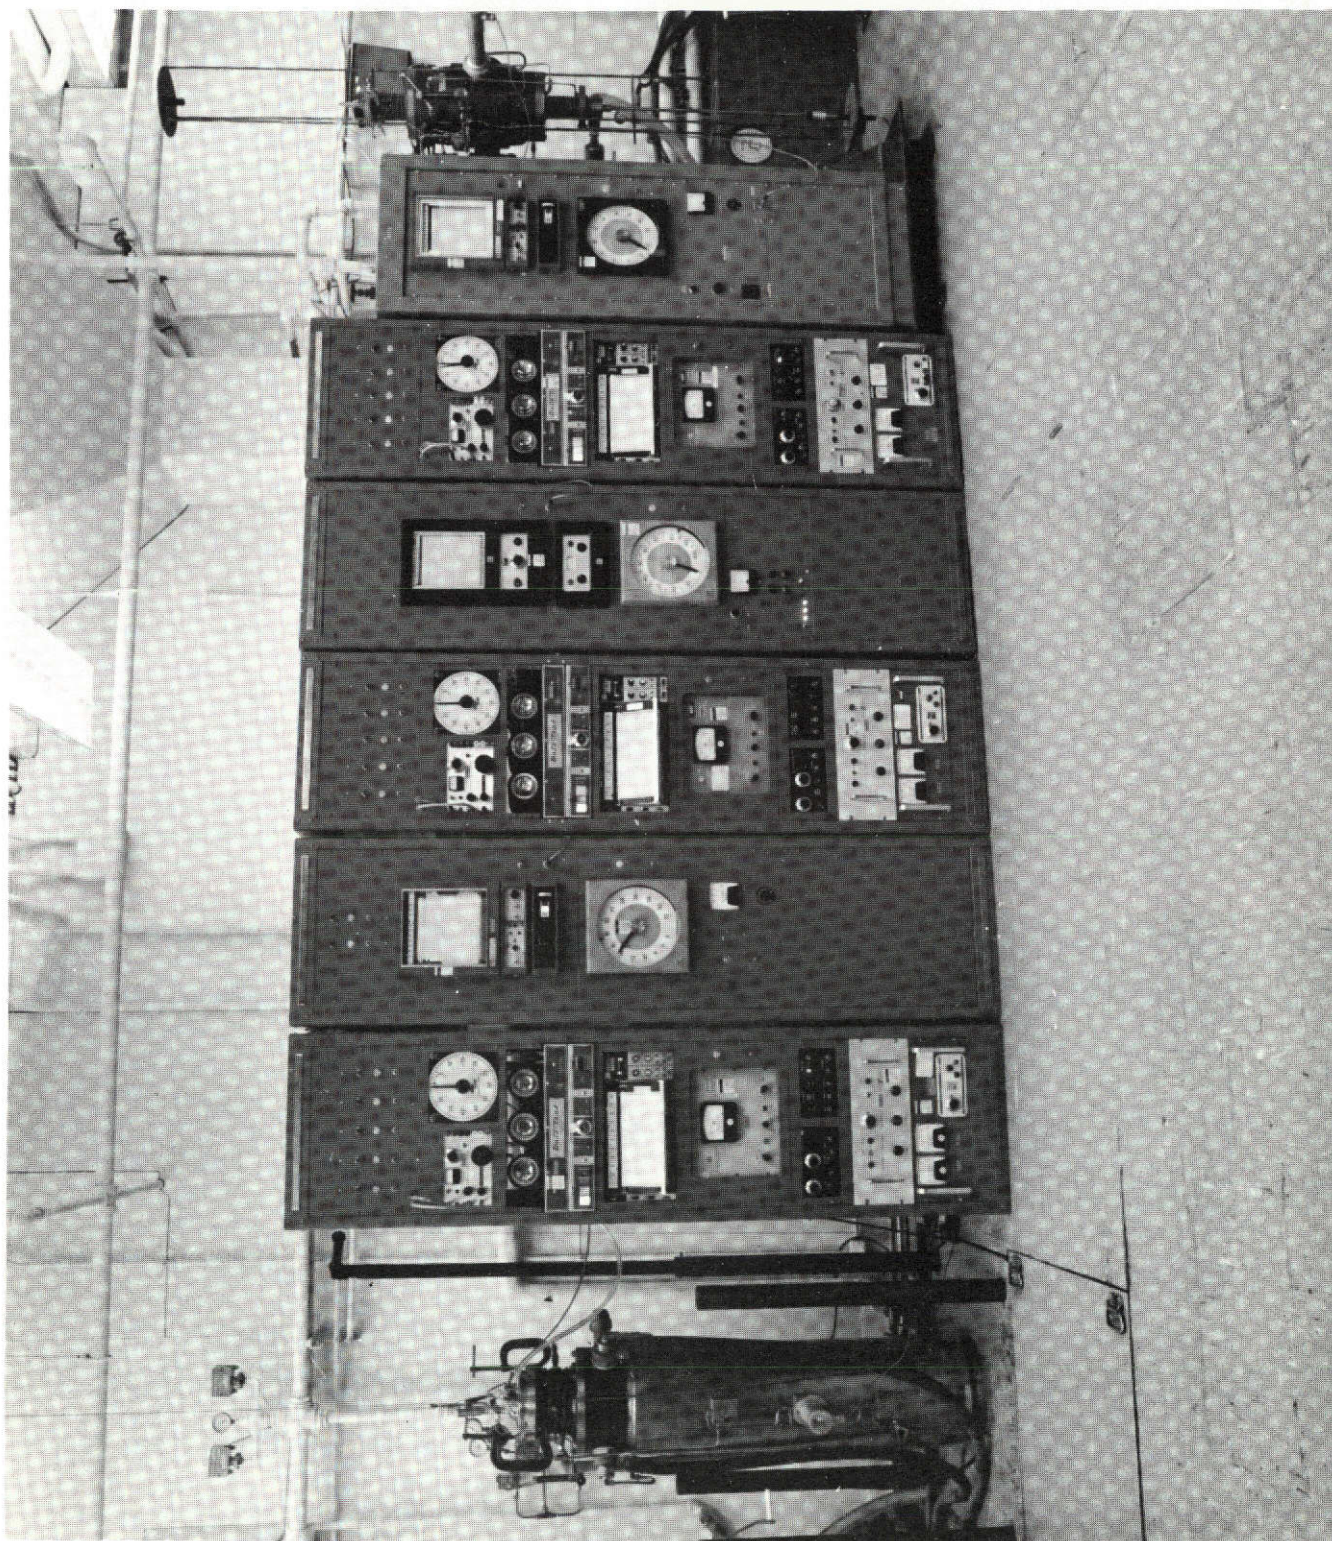
FIGURE 16 TEST APPARATUS USED FOR REENTRY PROFILE EXPOSURE CYCLING

Reentry profile exposure cycling was accomplished in the apparatus shown in figure 16. The specimens to be exposed were positioned in the center of the hot zone of the 4.5 centimeter diameter tube furnace. The temperature, air pressure and stress were varied independently as a function of reentry time by a system of automated programmers, controllers, and recorders. The test conditions used are shown in figure 17. These were selected because they represent a broad range of hypersonic reentry conditions and are the same as those employed on other current columbium evaluation programs (references 7 and 9). Exposure cycles were performed in groups of 22, unless fewer were required to achieve a specific desired number of cycles.

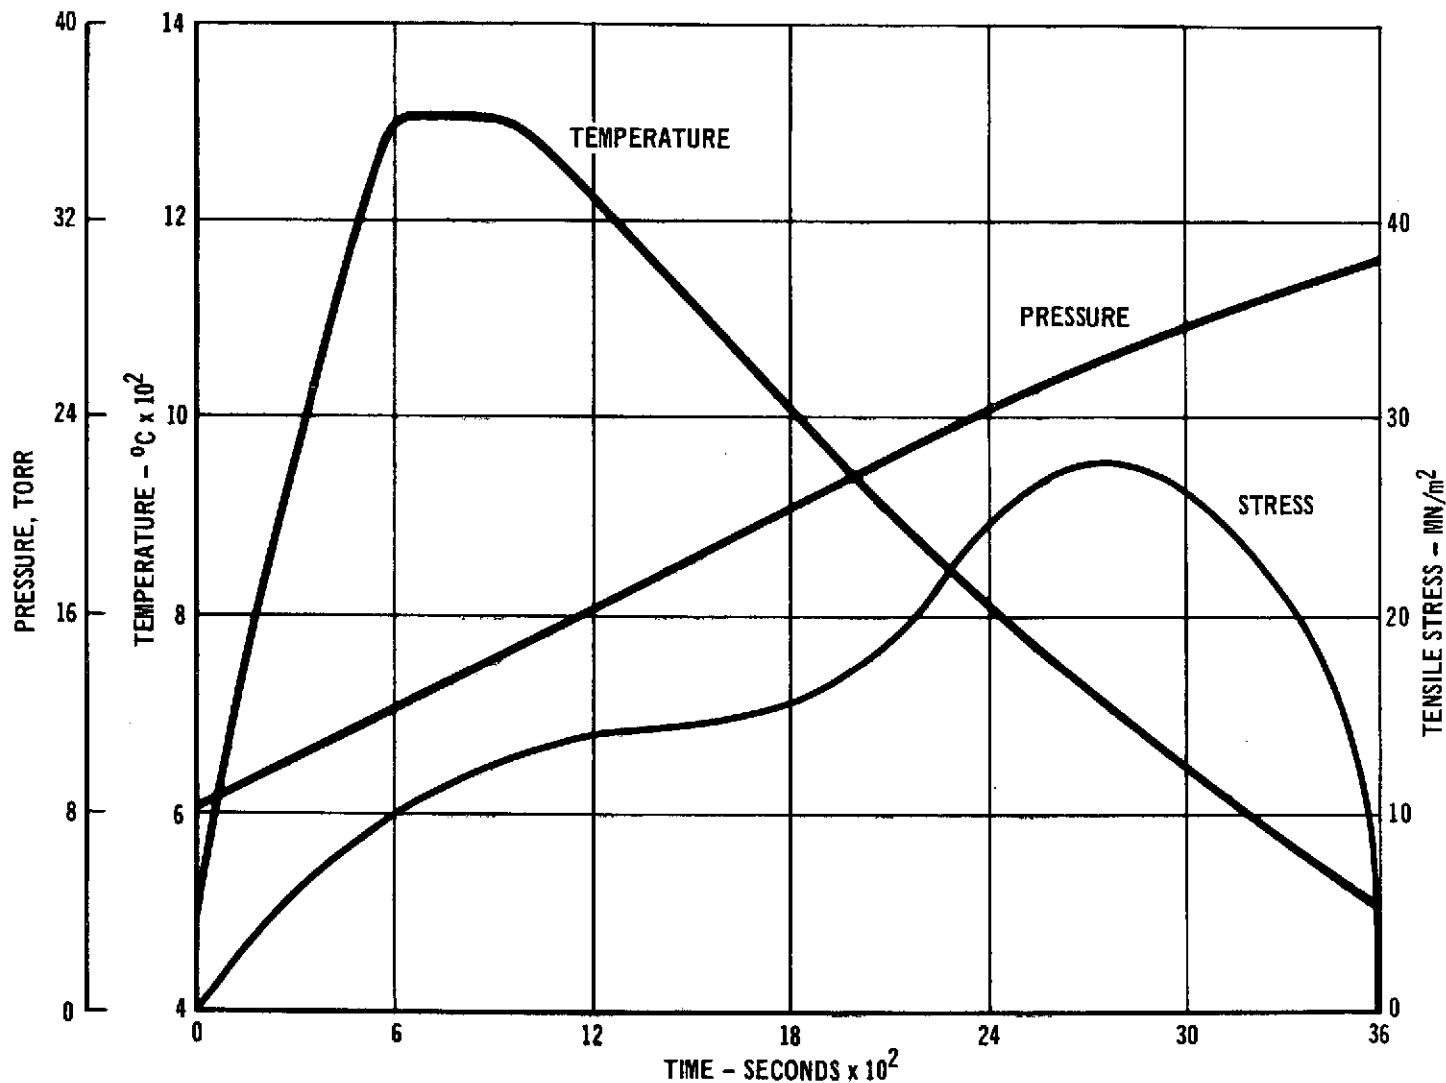
FIGURE 17|TEST CONDITIONS USED FOR REENTRY PROFILE EXPOSURE TESTING

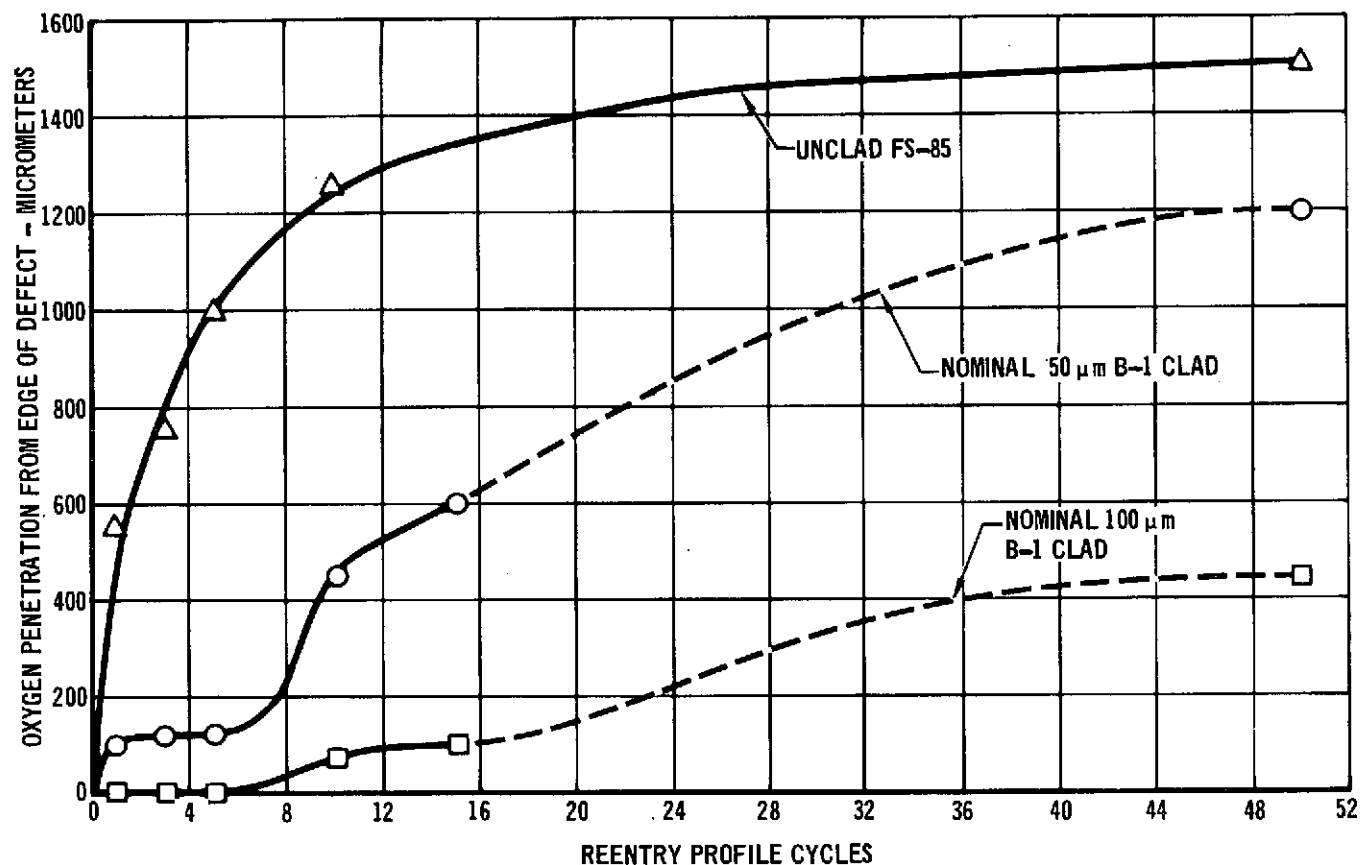
FIGURE 19 DEPTH OF OXYGEN PENETRATION IN B-1 CLAD AND UNCLAD FS-85 ALLOY

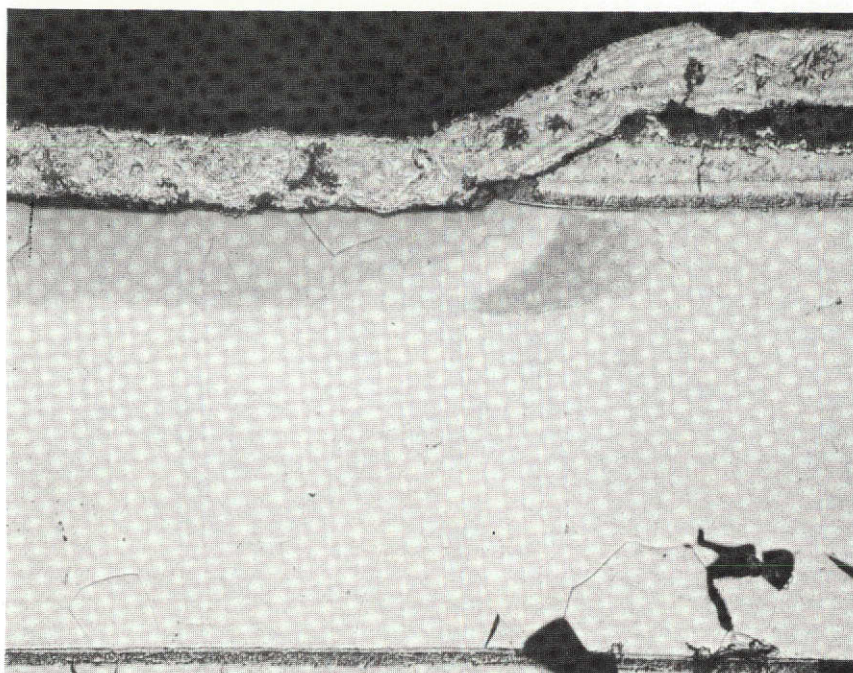
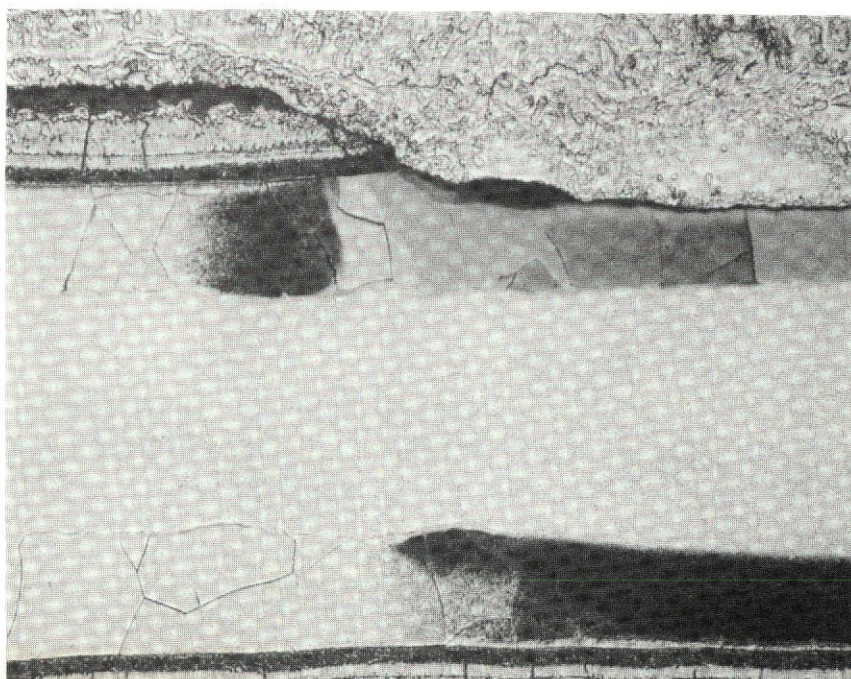
FIGURE 23 NOMINAL 100 MICROMETER THICK B-1 CLAD FS-85 AFTER
THREE AND FIVE EXPOSURE CYCLES

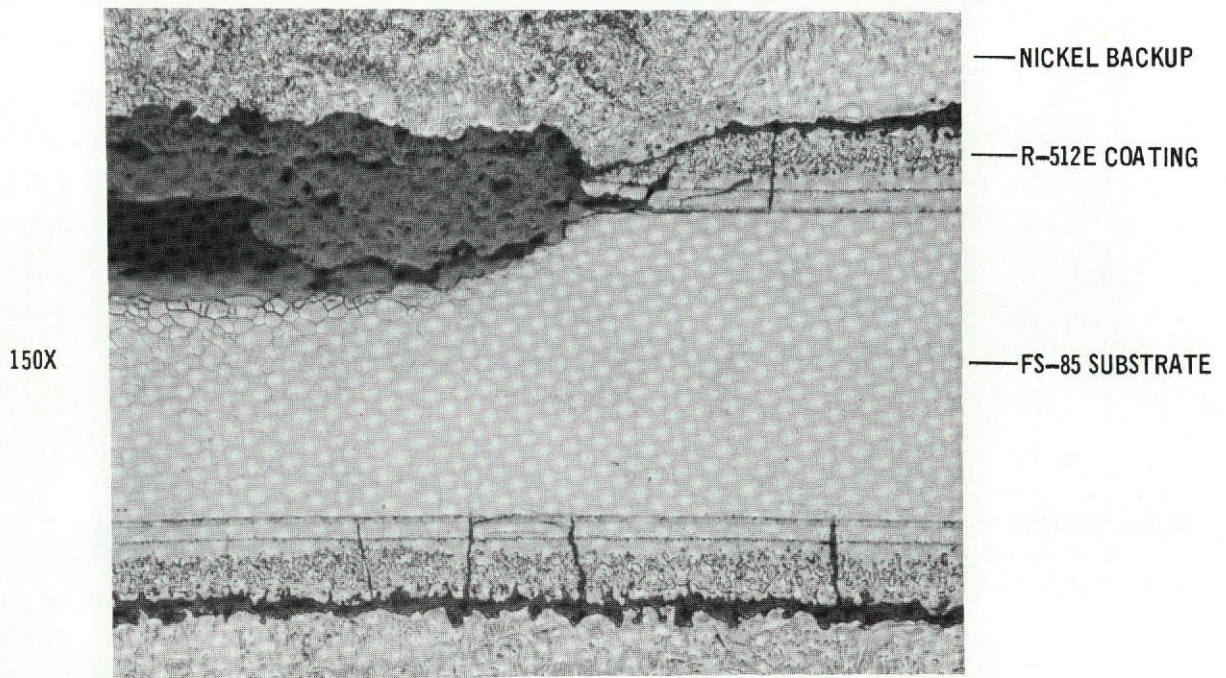
FIGURE 24 EFFECT OF FIVE REENTRY PROFILE EXPOSURE
CYCLES ON UNCLAD FS-85

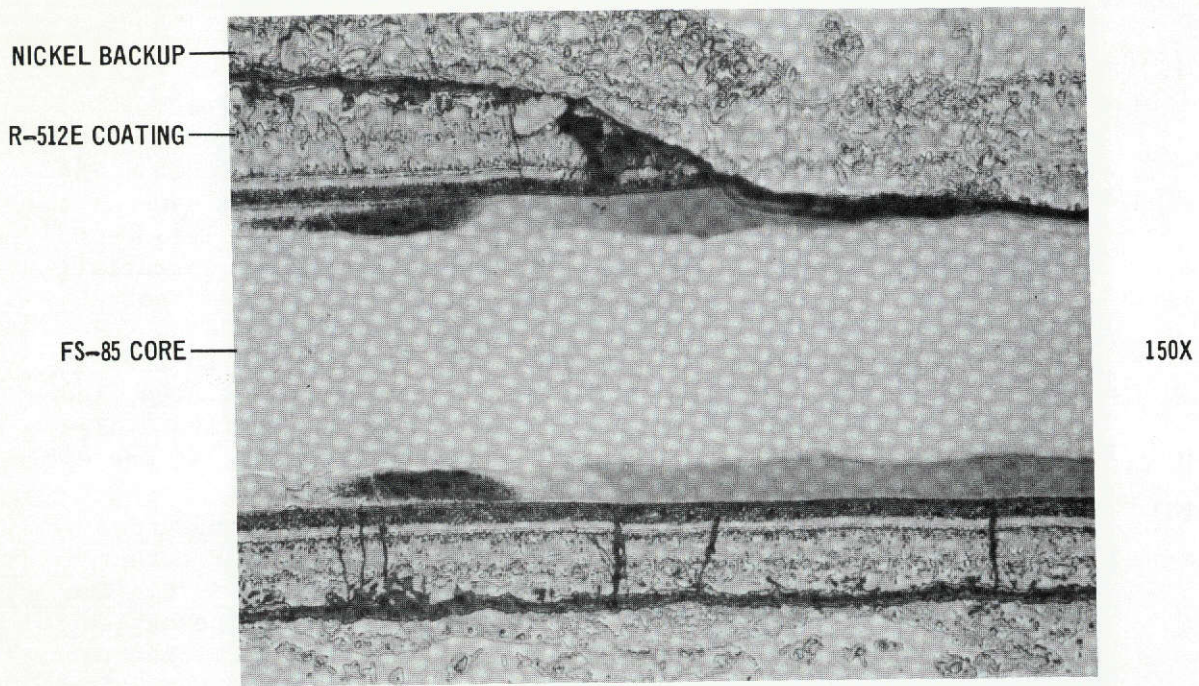
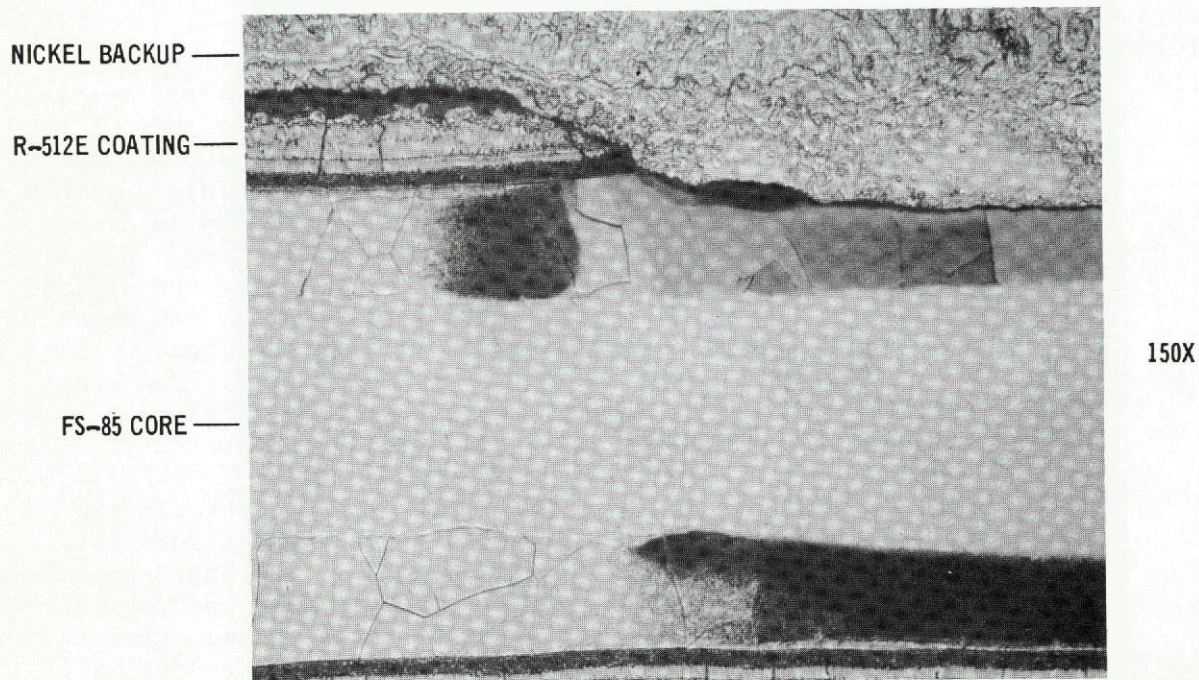
FIGURE 25 B-1 CLAD FS-85 AFTER FIVE REENTRY
PROFILE EXPOSURE CYCLES
